TECHNICAL REPORT REMR-CO-3

CASE HISTORIES OF CORPS BREAKWATER
AND JETTY STRUCTURES

Report 5

NORTH ATLANTIC DIVISION

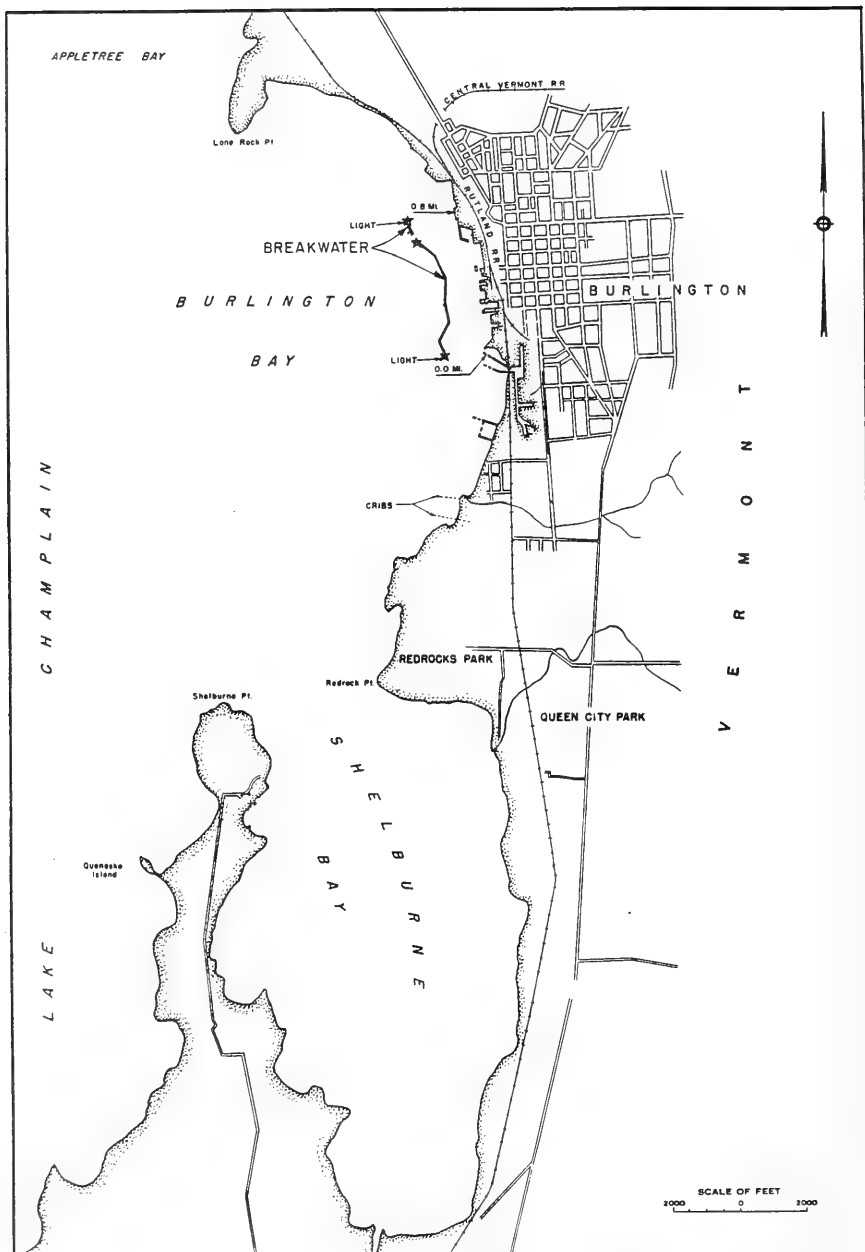
Figure 8. Burlington Harbor, Vermont

<u>Date(s)</u>	<u>Construction and Rehabilitation History</u>
1890	A 4,157-ft breakwater was completed after 54 years of construction (Figure 8). The breakwater consisted of two segments at lengths of 364 ft (north) and 3,793 ft (south) which were separated by 250 ft. Construction was of rubble mound resting on rock-filled timber cribs capped by either concrete (2,457 ft), or rock (1,700 ft). The cribs rested on a sand and gravel bed and were fastened with dowels and tenons. Crest elevation was +8.0 ft low lake level (lll), and crib width ranged from 24 to 34 ft.
1948	The breakwater was repaired. Stone was placed on the lakeside at weakened sections.
1960	A survey indicated the existing structure had settled 1.0 to 3.0 ft along the entire length. Deterioration of sections of the timber fasteners left unconnected sections and caused timber displacement and leaning of the structure lakeward. Deterioration was believed to be caused by wave action and ice conditions over long periods of time. Approximately 550 lin ft of the stone superstructure was undetermined. Eighty feet of the structure was breached.

1962- 1965	The breakwater was rehabilitated using 16,573 tons of stone at a cost of \$381,000.
1986	No further repair or maintenance information has been found.

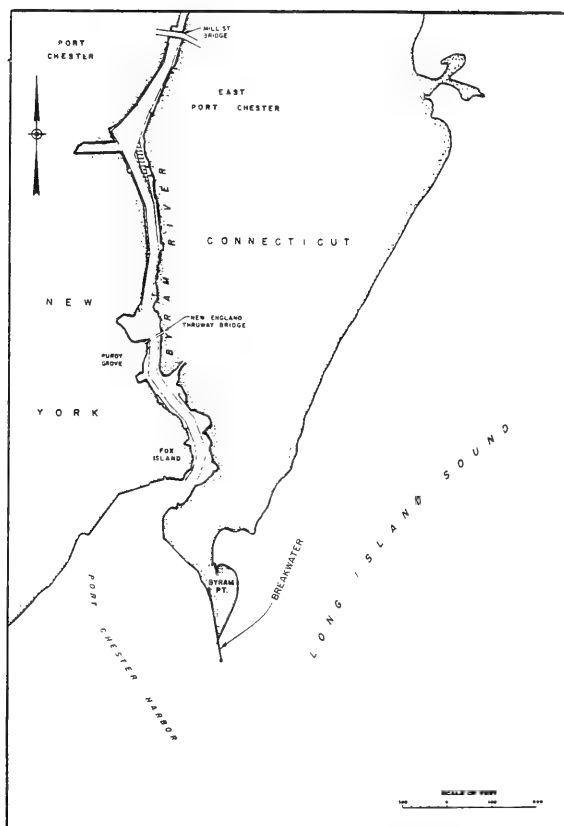
Figure 9. Port Chester Harbor, New York

<u>Date(s)</u>	<u>Construction and Rehabilitation History</u>
1895	A 783-ft-long rubble-mound breakwater was completed from Byram Point to Sunken Rock (Figure 9). Crest elevation was +15 ft mhw. The estimated cost of breakwater construction was \$25,000.
1963	The breakwater was repaired using 990 tons of stone. The cost of the repairs was \$25,500.
1986	No further repair or maintenance information has been found. The project has been deauthorized.

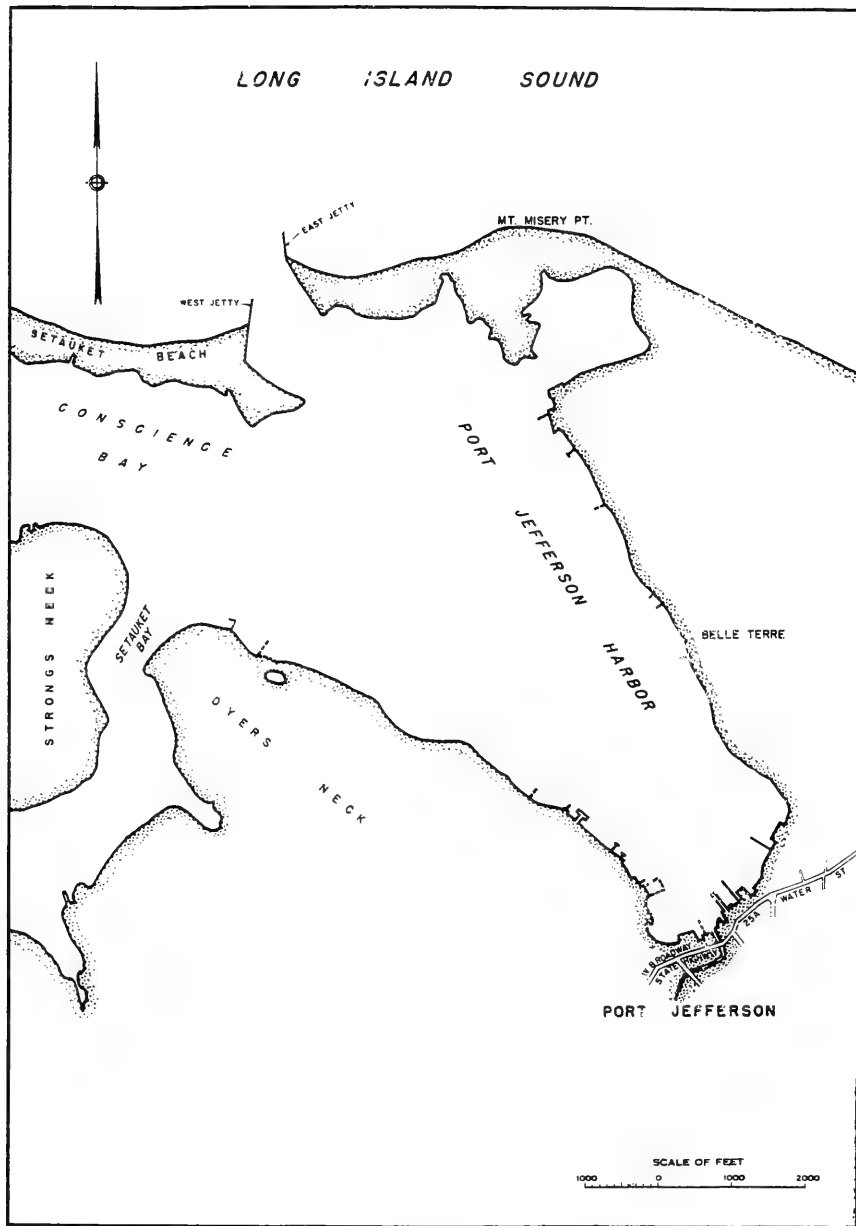
Figure 12. Port Jefferson Harbor, New York

1891	The east jetty was repaired over 600 ft with 1,464 tons of stone.
1908	The east jetty was extended to 1,550 ft (Figure 12).
1964	A survey indicated the jetties were in poor condition.
1986	No further repair or maintenance information has been found.

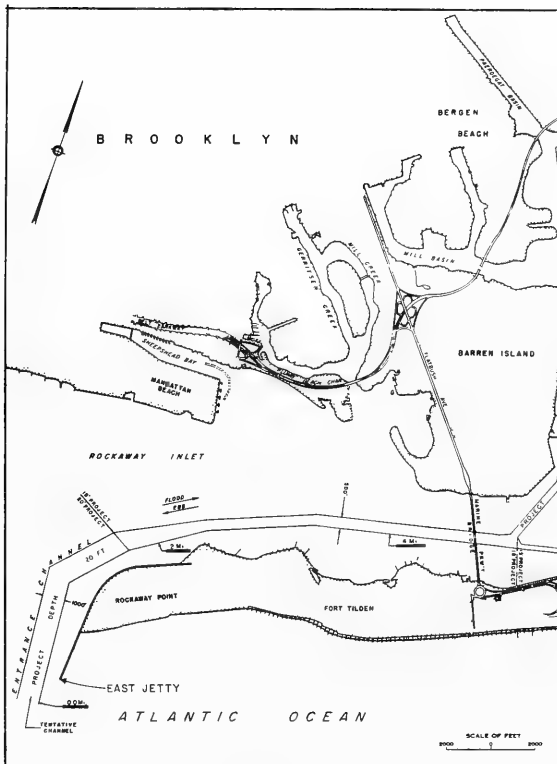
Figure 24. Jamaica Bay, New York

<u>Date(s)</u>	<u>Construction and Rehabilitation History</u>
1933	A jetty was constructed east of the bay entrance, 8,400 ft long, for channel protection (Figure 24). Plans called for construction of a west jetty.
1949	A survey of the jetty stated it was in fair condition.
1953	Repairs were made to 225 ft of the jetty using 580 tons of stone at a cost of \$14,088.
1963	The jetty was rehabilitated to project dimensions.
1986	No further repair or maintenance information is available on the east jetty. The west jetty has not been constructed.

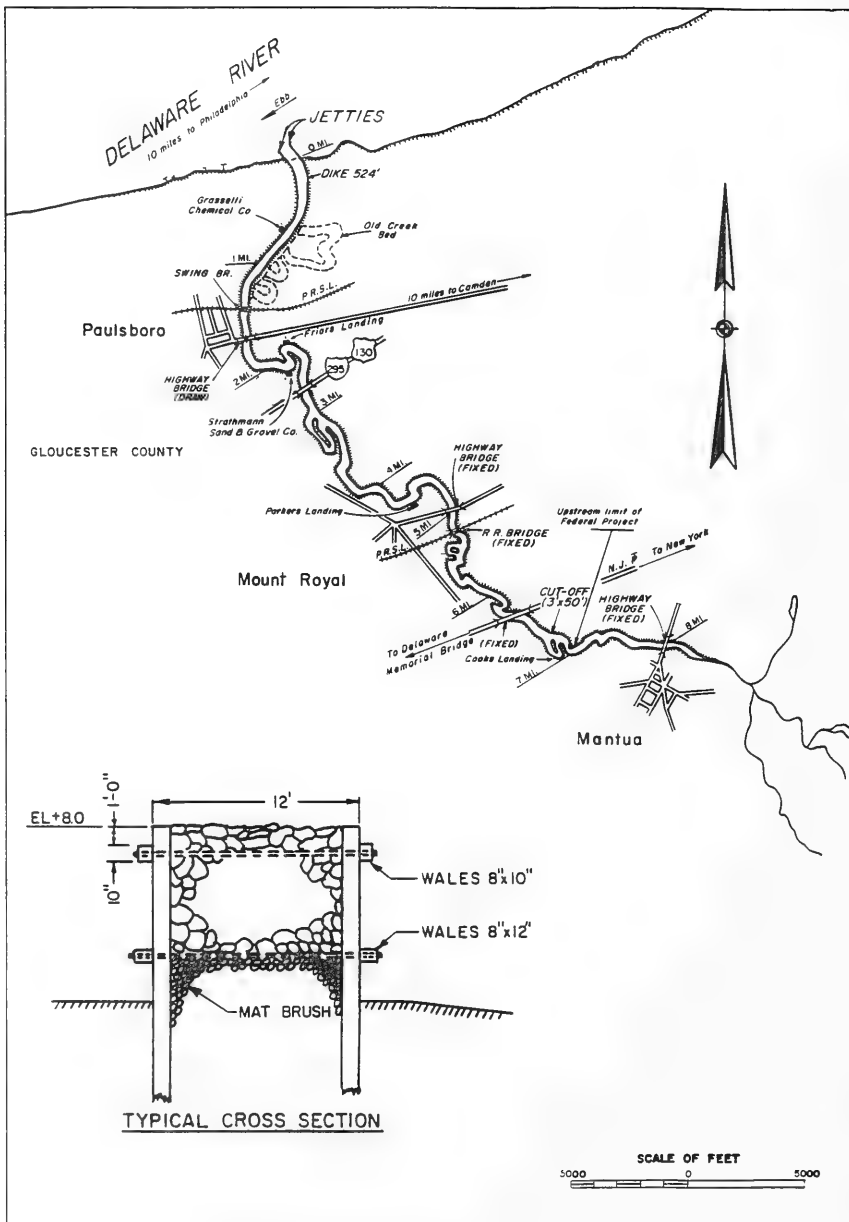
Figure 28. Mantua Creek, New Jersey

<u>Date(s)</u>	<u>Construction and Rehabilitation History</u>
1907	Two jetties were constructed to provide channel protection. Lengths were 754 ft and 580 ft east and west, respectively. The jetties were constructed of stone-filled timber cribs, with mat brush placed to support the stone (Figure 28). Top width and elevation were 12.0 ft and +8.0 ft mlw, respectively, for each jetty.
1912-1913	The east jetty was extended to 1,577 ft, and the west jetty was extended to 1,456 ft (Figure 28).
1918	Repairs were made by the addition of stone.
1962	An investigation of the jetties revealed the jetties had settled an average of 2.0 ft. Approximately 100 ft of the offshore end of the east jetty had deteriorated, with most of the pilings gone, and stone had fallen out to below the waterline. Most of the walings had deteriorated and were missing. Piles were missing at intermediate locations along the jetties, but there was no significant loss of stone at those locations. Piles that remained were in good condition.

1963	The jetties were rehabilitated at a cost of \$136,895. A new row of piles was placed over approximately 100 ft at the offshore ends. Piles were placed 7.5 ft on either side of the center line of the jetties. Corestone was dumped between the piles to an elevation of +8.0 ft mlw (Figure 29). Missing piles were replaced, and new wales were provided along the remainder of the jetties. One row of capstone was placed on the inner sides of both cribs on top of the existing stone to +8.0 ft mlw. Core stone was filled between the capstones in the center of the jetties to +8.0 ft mlw (Figure 29). Crown width was 16.0 ft at the offshore ends and 12.0 ft on the remainder of the jetty. Design wave height was 4.2 ft.
1964	Repairs were made to the seaward end of the east jetty at a cost of \$4,864. The Corps was reimbursed later for this work.
1986	No further repair or maintenance information has been found.

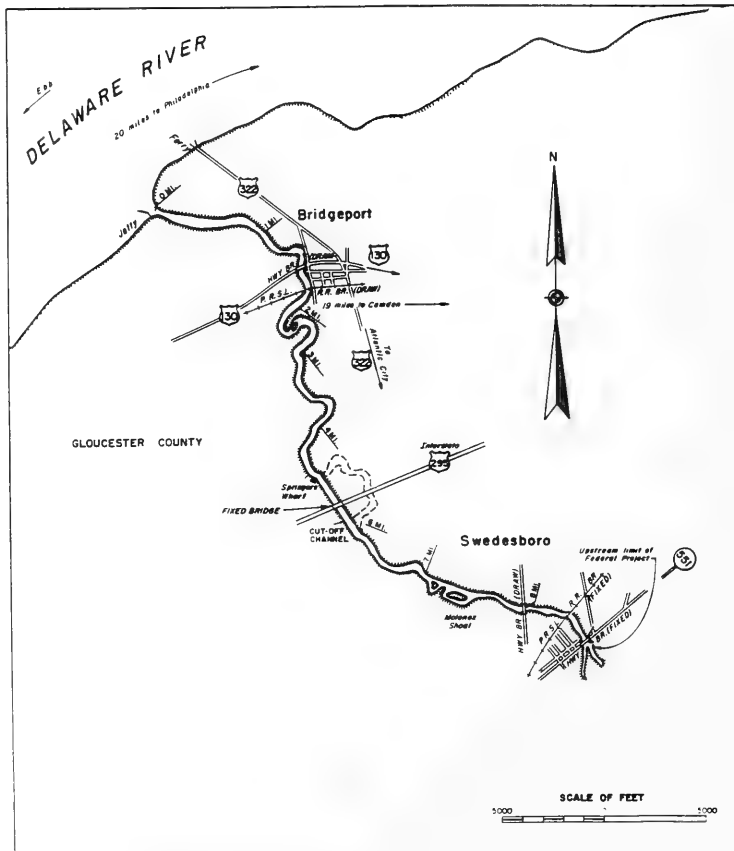
Figure 30. Raccoon Creek, New Jersey

Date(s)	Construction and Rehabilitation History
1922	A 950-ft-long timber pile, brush, and stone jetty was constructed south of the entrance to provide channel protection (Figure 30). The cost of construction was \$29,159.
1986	No further repair or maintenance information has been found.

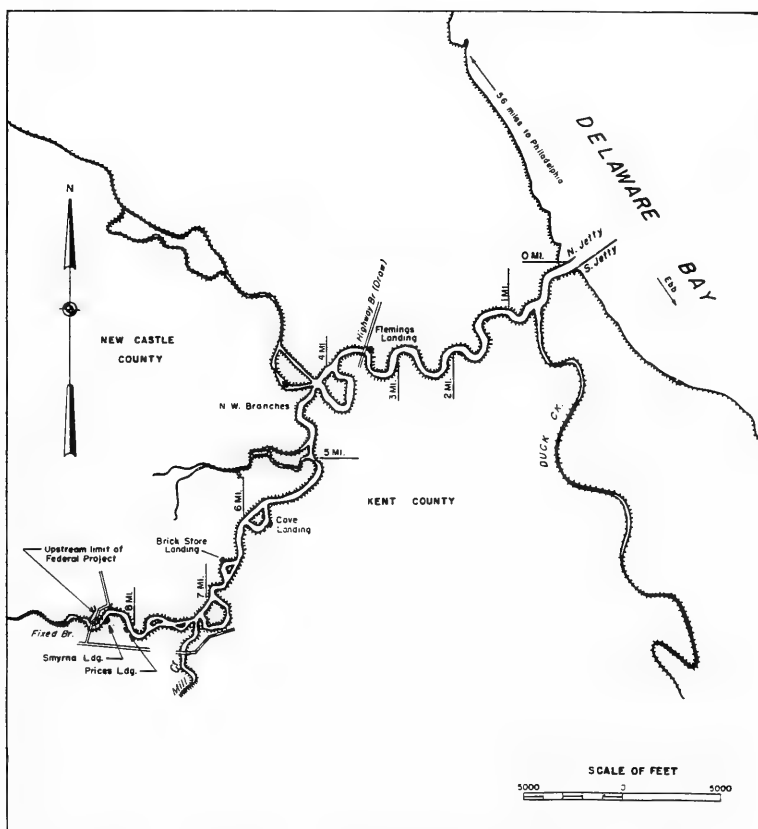
Figure 33. Smyrna River, Delaware

Date(s)	Construction and Rehabilitation History
1939	Two parallel stone-filled timber crib jetties were constructed to provide channel protection. The north jetty was 803 ft, and original plans called for the south jetty to be 2,700 ft; however, project maps indicate it was approximately 2,000 ft (Figure 33).
1986	There is no records of repairs. The project has been deauthorized.

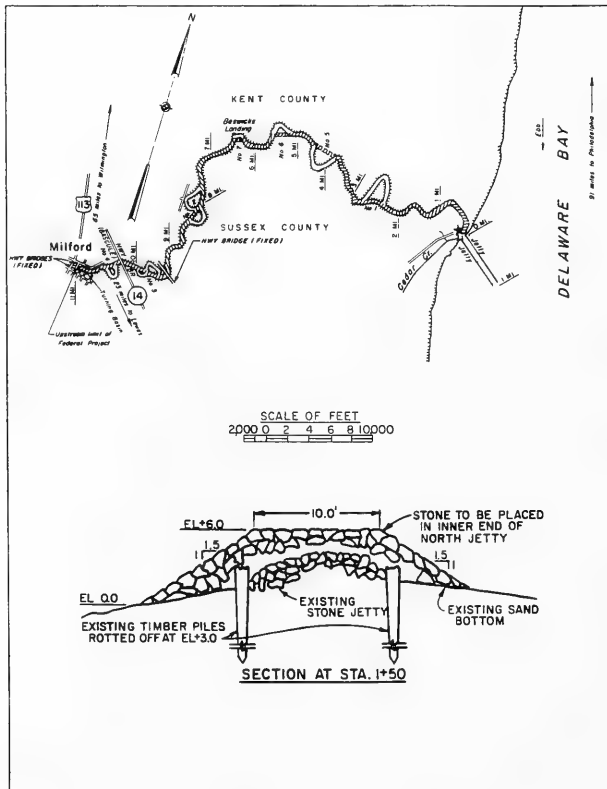
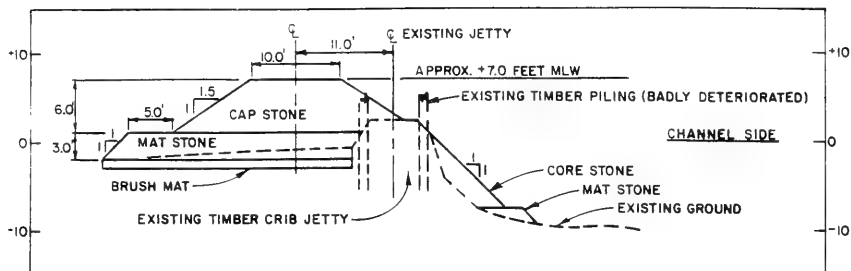
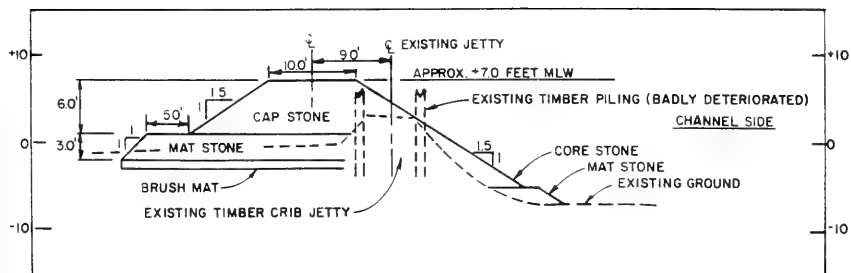
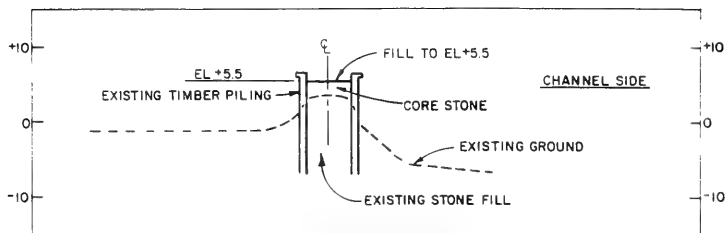
Figure 34. Mispillion River, Delaware

1944	Tops of piles were coated with tar on the north jetty near the river mouth at a cost of \$320.
1948	The north jetty was repaired beginning 708 ft from the shoreward end and extending 942 ft seaward. The original timber crib section was rehabilitated to a rubble-mound structure (Figure 34). The cost of repairs was \$51,493, and 4,870 tons of stone were used.
1963	A survey of the north jetty indicated there was no visible trace of the shoreward 708 ft. The total length of the existing jetty was 5,642 ft. The shoreward, rubble-mound, end had an average height of +6.2 ft mlw. The 1,200-ft-long timber crib structure adjacent to the rubble-mound section had deteriorated. Upper crib work was virtually nonexistent, and tops of piles were rotted or broken off. Stone had settled an average of 2.8 ft from design, was displaced, and had spilled out between piles. Piles, tie rods, and wales in the most seaward 3,500 ft appeared to be in good condition. Stone had settled an average of 1.5 ft in this section.

1964	Minor rehabilitation was done on the north jetty at a cost of \$377,848. The 1,200-ft-long deteriorated timber crib section was rehabilitated to a rubble-mound structure. The center line of the rubble-mound structure was placed north of the center line of the timber crib jetty to prevent failure of the jetty on the channel side due to lateral forces. The offset was 11.0 ft over a distance of 650 ft and 9.0 ft over a distance of 400 ft, shoreward and seaward ends of the section, respectively. Transition sections were on either end of the new structure and between the two offset sections. Crest elevation was +7.0 ft mlw, crown width was 10.0 ft, and side slopes were 1V:1.5H. Twenty-five ton minimum capstone was placed over 1- to 50-lb matstone. A layer of willow matting, compressed in

Date(s)	Construction and Rehabilitation History
1964 (Cont.)	place to 1.5 ft thick, was provided as a filter. Core stone, 25 to 500 lb, was placed on the channel side of the existing jetty at a slope of 1V:1H to 1V:1.5H to ensure stability of the rubble-mound structure. The 3,500-ft-long timber crib on the seaward end of the jetty was filled with core stone, 150 to 300 lb, to the original design elevation of +5.5 ft mlw. Cross sections of the rehabilitation are shown in Figure 35.
1985	The jetties are in good condition and have been effective in providing safe navigation and preventing channel shoaling.

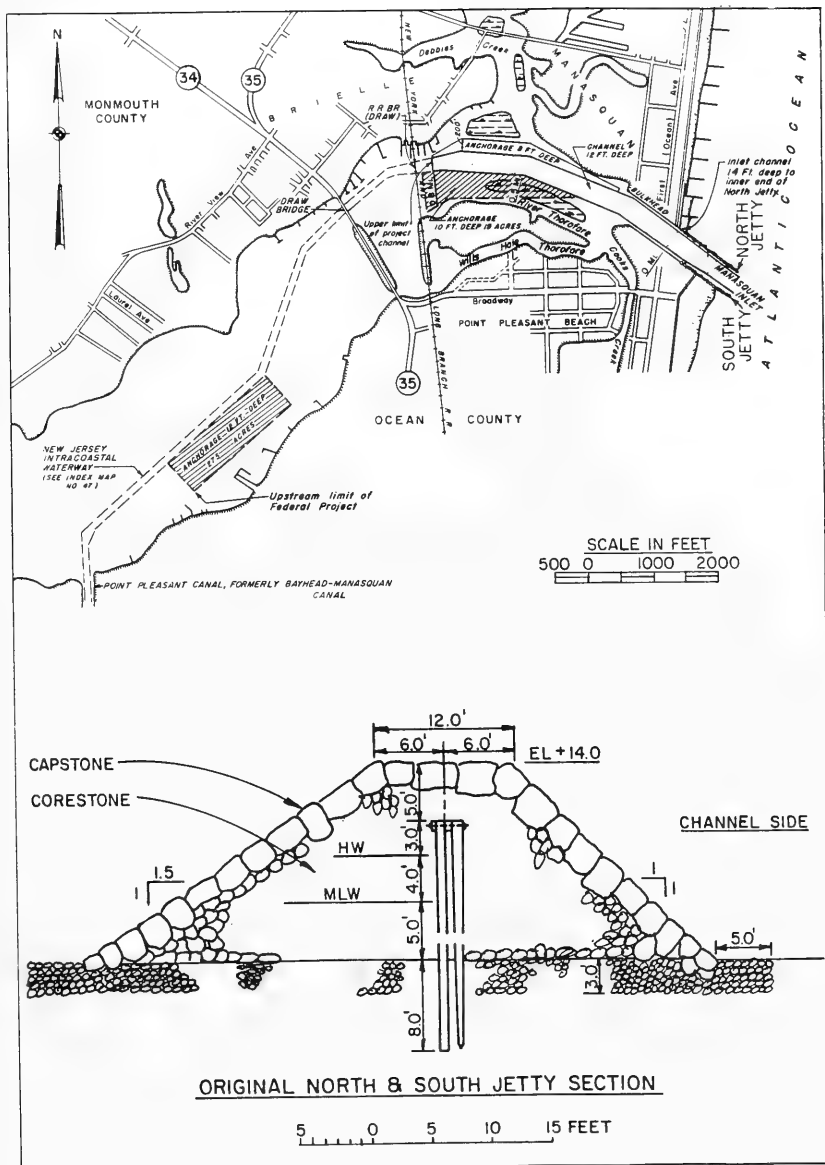
Figure 38. Manasquan River, New Jersey

Date(s)	Construction and Rehabilitation History
1979- 1982 (Cont.)	the south side. The seaward 240 ft was concrete capped, 35 ft wide at the seaward end and 20 ft wide elsewhere. Capstone was placed shoreward of the dolosse section, 375 ft on the north side and crest, and 90 ft on the south side. Capstone size decreased in the shoreward direction from 12.0 to 3.0 to 5.0 tons. Design wave height was 25.0 ft. An aerial photograph of the rehabilitation is shown in Figure 39.
1985	The jetties were subjected to several storms after the 1982 rehabilitation, including a design level storm in March 1984. Photogrammetric monitoring of the structures under the Monitoring of Completed Coastal Projects (MCCP) Program indicated the last rehabilitation of the jetties has been fully successful to date.

Date(s)	Construction and Rehabilitation History
1882	A 1,515-ft-long timber jetty and dike was constructed north of the inlet.
1883	A timber jetty was constructed south of the inlet to a length of approximately 500 ft.
1886	The south jetty was flanked, and use of the inlet was seriously impaired.
1922	New timber jetties were constructed.
1924	The jetties were in a state of disrepair.
1930- 1931	Two rubble-mound jetties were constructed north and south of the inlet to replace the timber jetties and provide channel protection. The north jetty was 1,230 ft long, and the south jetty was 1,030 ft long. The jetties were spaced 400 ft apart and built to an elevation of +14 ft mlw, with a 12.0-ft crown width and side slopes of 1V:1.5H on the ocean side, and 1V:1H on the channel side (Figure 38). Capstone was 2.0 ton, and core stone ranged from 100 to 500 lb.
1946	Both jetties were rehabilitated using 5,190 tons of capstone, 2,886 tons of corestone, and 628 cu yd of grout. The cost of rehabilitation was \$56,778.

1955	The north jetty was rehabilitated using 5,400 tons of stone at a cost of \$128,597.
1959	The south jetty was rehabilitated using 12.0-ton capstone at a cost of \$67,048.
1977	The seaward 100 ft and 60 ft of the north and south jetties, respectively, were destroyed through continued displacement of armor stone and loss of structural integrity. The south jetty was damaged from the seaward end to 700 ft shoreward. Sand passed from the south jetty fillet through and over the jetty into the inlet.
1979- 1982	Both jetties were rehabilitated using dolosse. Sand and displaced stone were excavated and reshaped to design configuration before dolosse placement. Sixteen-ton dolosse were placed along the seaward 400 ft on the north side of the south jetty, around the jetty head, and along the seaward 50 ft on the south side. The dolosse extended to -10 ft mlw on the channel side, with side slopes of 1V:2H, and front slopes of 1V:3H. The seaward 400 ft was concrete capped, 20 ft wide, and was built at an elevation of +14 ft mlw. Sixteen-ton dolosse were placed along the seaward 250 ft on the north side of the north jetty, around the jetty head, and along the seaward 90 ft on

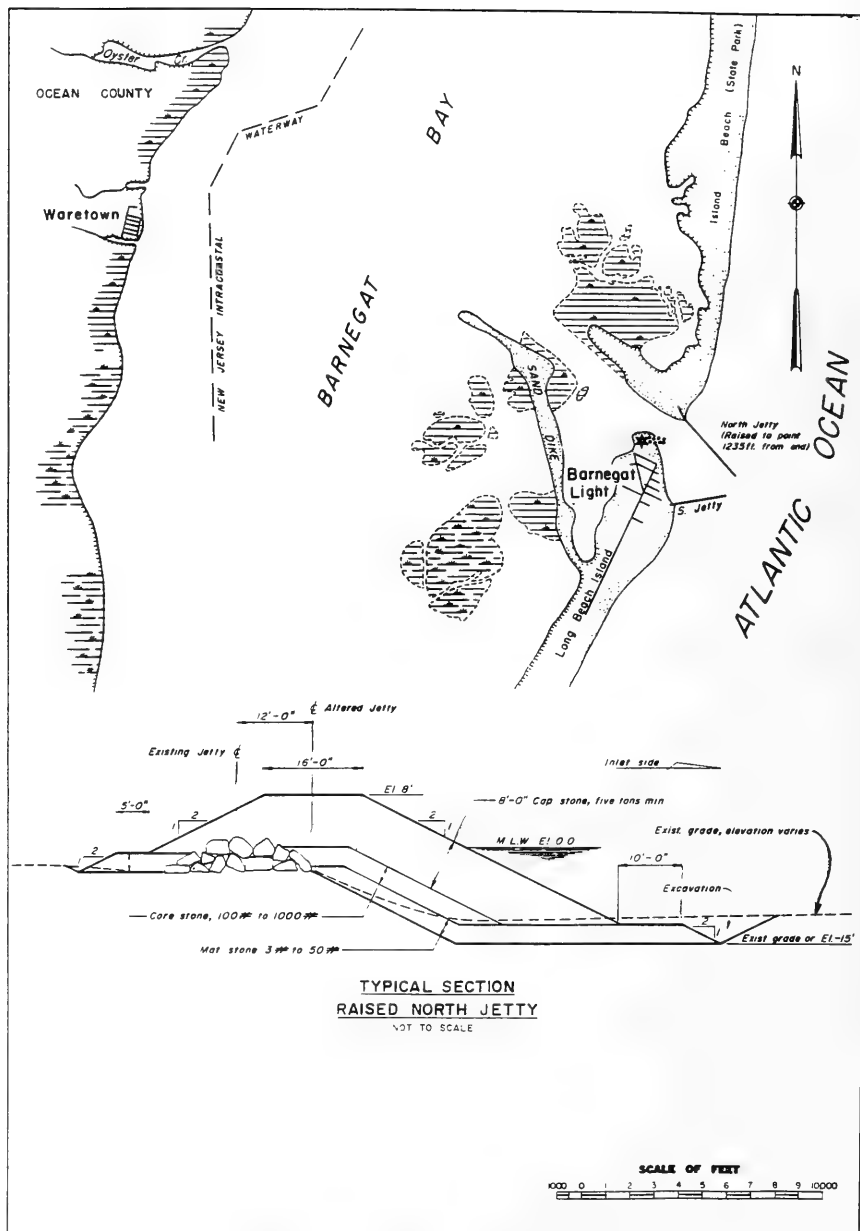
Figure 40. Barnegat Inlet, New Jersey

<u>Date(s)</u>	<u>Construction and Rehabilitation History</u>
1940	Two converging stone jetties were constructed north and south of the inlet for channel protection. The north jetty was 4,675 ft long, and the south jetty was 2,820 ft long (Figure 40). Design crest elevation was +2.0 ft mlw.
1944	The shoreward 100 ft of the south jetty was lowered.
1950	Repairs were made to the seaward end of the north jetty.
1954	Repairs were made to the shoreward portion of the south jetty.
1972- 1974	To prevent sand passing through and waves overtopping the north jetty, the shoreward 3,700 ft was raised to +8.0 ft mlw and made impermeable. The center line of the section repaired was offset 12.0 ft toward the inlet from the existing section (Figure 40).
1985	Due to instability and continuous shoaling of the navigation channel, proposals are being considered to construct a new south jetty. Portions of the jetties have crest elevations of +10.0 ft mlw. These sections were probably built as part of repair work conducted in 1950 and 1954. Figure 41 is an aerial photograph of the jetties in 1984.

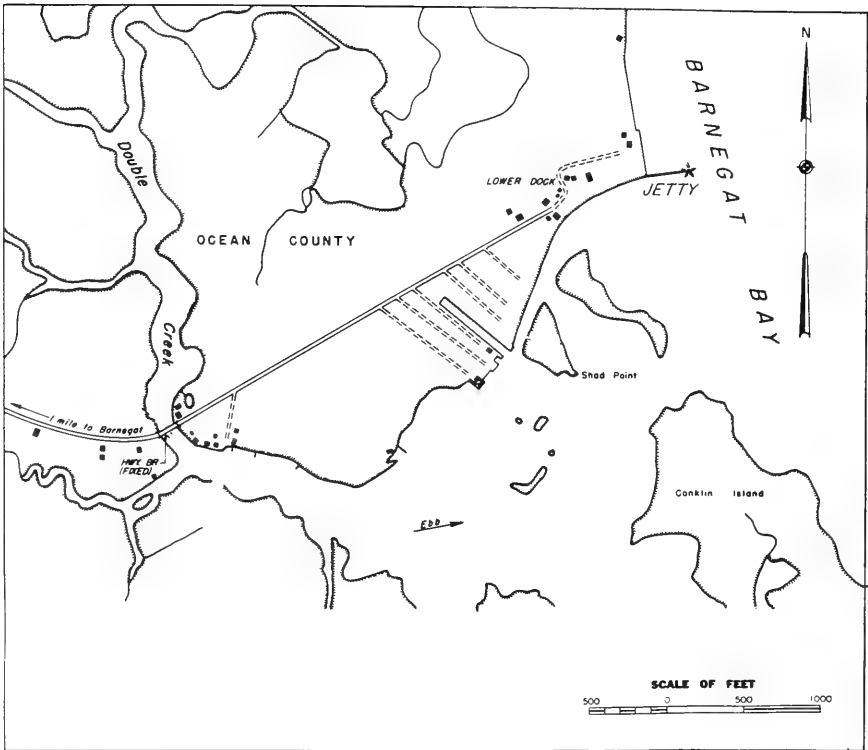
Figure 42. Double Creek, New Jersey

Date(s)	Construction and Rehabilitation History
1912	A 550-ft-long timber pile jetty was constructed to provide channel control (Figure 42).
1986	There is no repair history.

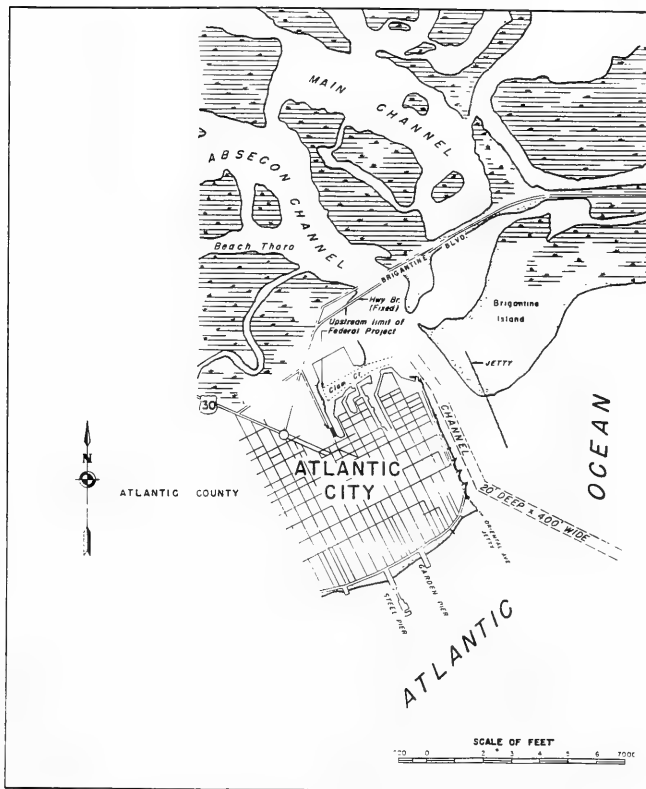
Figure 43. Absecon Inlet, New Jersey

Date(s)	Construction and Rehabilitation History
1948	Construction began on a 3,727-ft-long jetty on the east side of the harbor for channel control. Crest elevation was +8.0 ft mhw. An 800-ft-long groin served as a jetty on the west side of the harbor (Figure 43).
1986	No repair or rehabilitation history is available. Figure 44 is an aerial photograph of the jetties in 1971.

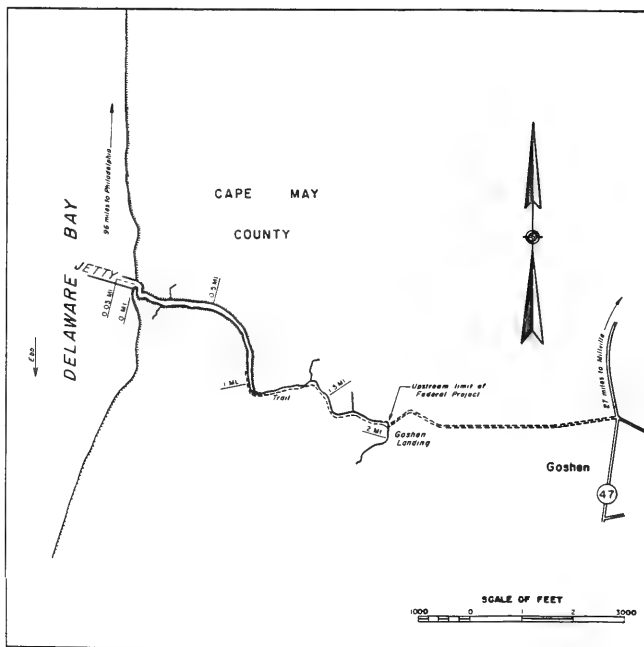
Figure 45. Goshen Creek, New Jersey

<u>Date(s)</u>	<u>Construction and Rehabilitation History</u>
1897	A 600-ft-long sheet-pile jetty was constructed south of the entrance to provide channel control.
1898	The south jetty was extended shoreward to maintain the dredged channel.
1899	The south jetty was repaired with brush and stone and extended to 680 ft. A jetty was constructed north of the entrance, parallel to the south jetty, at a length of 680 ft (Figure 45).
1986	The south jetty is now 1,800 ft long (Figure 45), but the date of the extension is unknown. No history is available on maintenance in this century, and the project is specified as inactive.

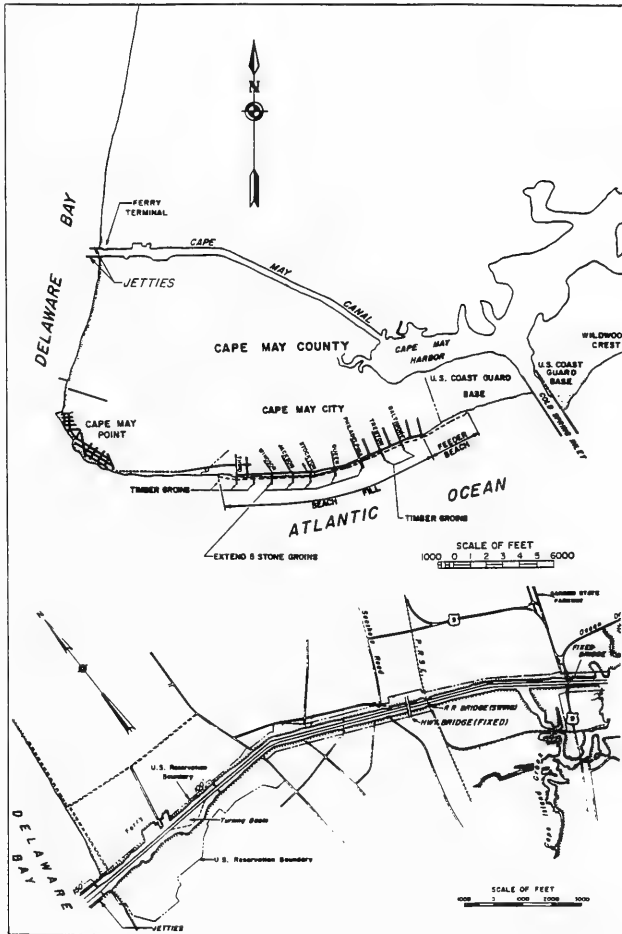
Figure 48. Cape May Harbor to Delaware Bay Canal, New Jersey

<u>Date(s)</u>	<u>Construction and Rehabilitation History</u>
1943	Two parallel jetties were constructed on either side of the entrance for channel protection (Figure 48).
1986	No jetty repair information was found. Lengths of the jetties are approximately 600 ft and 700 ft north and south, respectively.

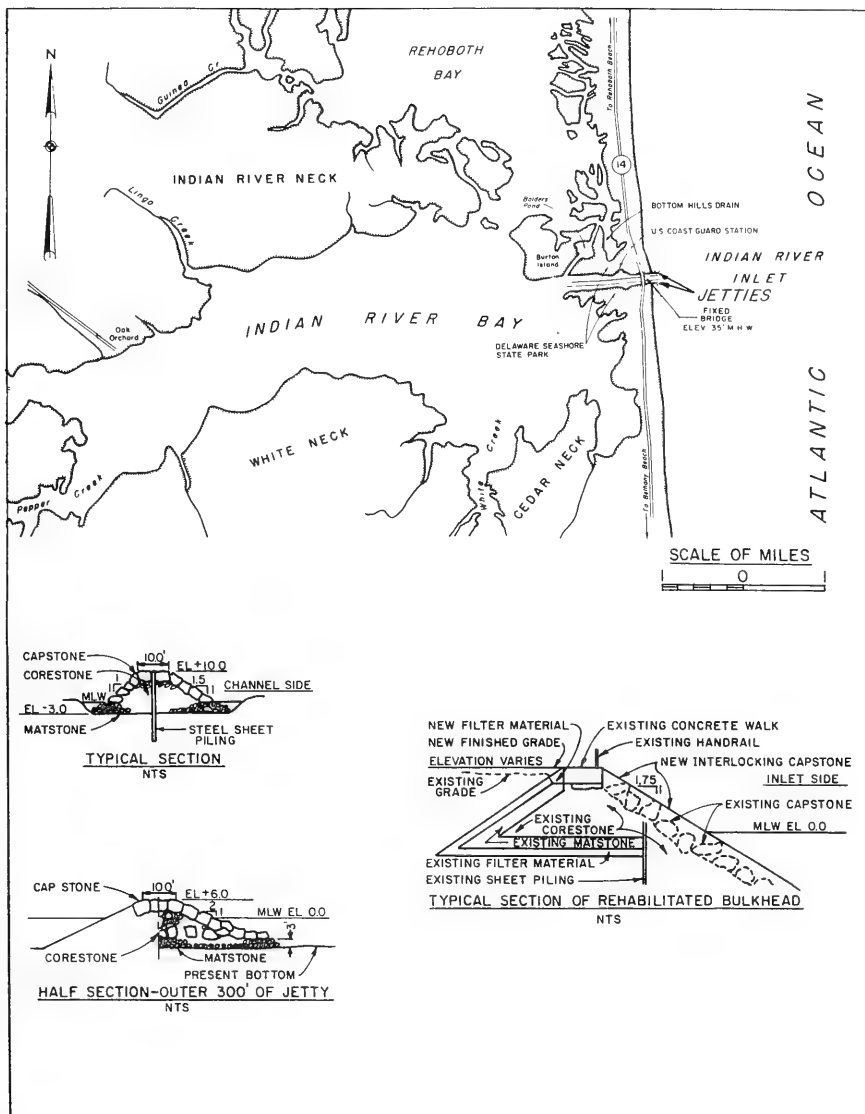
Figure 49. Indian River Inlet, Delaware

<u>Date(s)</u>	<u>Construction and Rehabilitation History</u>
1939	Two parallel jetties were completed to provide inlet protection. The jetties were 1,566 ft long and 500 ft apart. The shoreward 904 ft and 890 ft of the north and south jetties, respectively, were constructed of steel sheet pile, and the seaward portions were constructed of stone. The stone jetties had a crest elevation of +6.0 ft mlw, a crown width of 10.0 ft, and side slopes of 1V:1.5H (Figure 49).
1956	Storm damages to the south jetty were repaired.
1957	The north jetty was repaired because of storm damages and was extended shoreward 320 ft because of shoreline recession and deterioration of the sheet pile (Figure 49).
1985	The jetty heads are in poor condition because of slope failure, subsidence, and toe scour. Repair alternatives have been proposed, and the use of dolosse has been suggested. Figure 50 is an aerial photograph of the jetties taken in 1985.

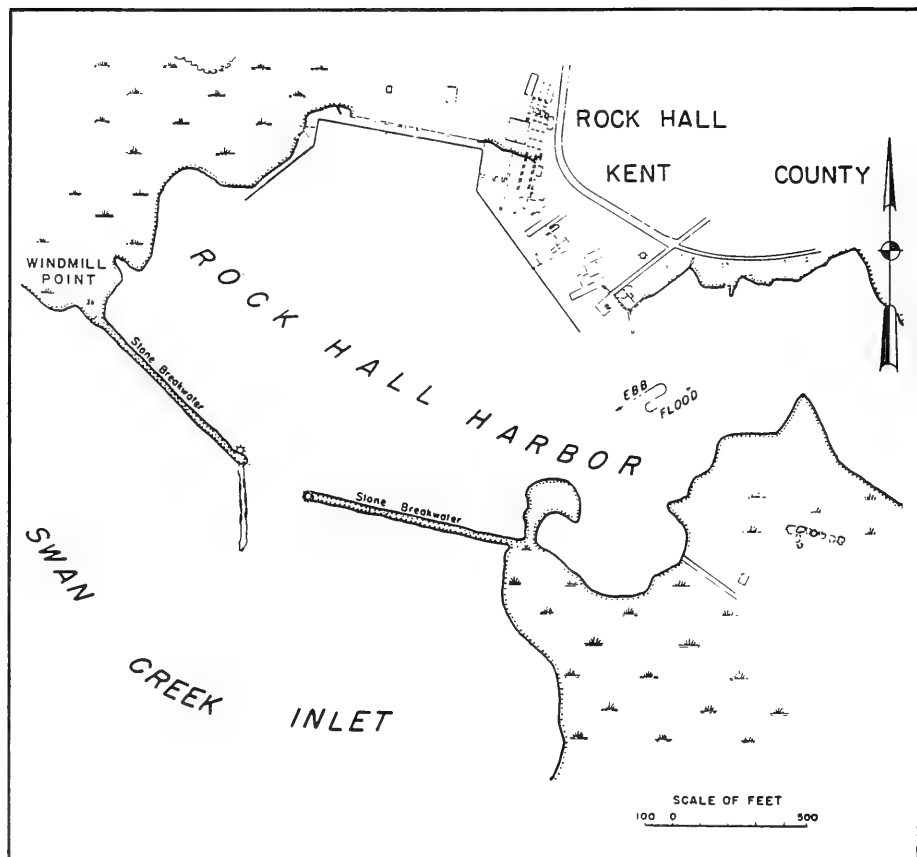
Figure 51. Rock Hall Harbor, Maryland

1982	Extensive rehabilitation was done to both breakwaters due to wave transmission and overtopping causing excessive wave heights (greater than 4.0 ft) in the inner harbor. Estimated cost of the rehabilitation was \$1,800,000 and required over 27,000 tons of stone. Crown elevation was raised to +7.0 ft mlw, crown width was widened to 8.0 ft with three capstones, and side slopes remained 1V:1.5H requiring 12,400 tons of stone. The west breakwater was extended to 1,100 ft requiring 14,800 tons of stone. Cover stone used for rehabilitation ranged from 2,300 lb at the trunk to 2,800 lb at the head. Cross sections and location of the rehabilitation are shown in Figure 52.
1986	No further repair or maintenance information has been found.

<u>Date(s)</u>	<u>Construction and Rehabilitation History</u>
1939	Two breakwaters were constructed with 8,400 tons of stone. Lengths of the breakwaters were 850 ft and 700 ft east and west, respectively (Figure 51). Elevations of the breakwaters were +4.0 ft mlw, with a single capstone, crown width of 4.0 ft, and side slopes of 1V:1.5H.
1964	Repairs were made on both breakwaters to restore them to original design geometry. The east breakwater was in good condition with crest subsidence of less than 0.5 ft. The majority of the repairs were made on the west breakwater. The landward 80 ft had subsided up to 2.0 ft, the seaward 50 ft had subsided to mlw, and the adjacent 380 ft had subsided 1.0 to 2.5 ft. The landward ends of both breakwaters were repaired with 250- to 500-lb stone. A 40-ft extension was added to the west breakwater (Figure 51), and the outer 220 ft, including the extension, were repaired with 1,000 to 2,000-lb cover and core stone. The adjacent 260 ft were raised by filling the existing section with additional core stone.

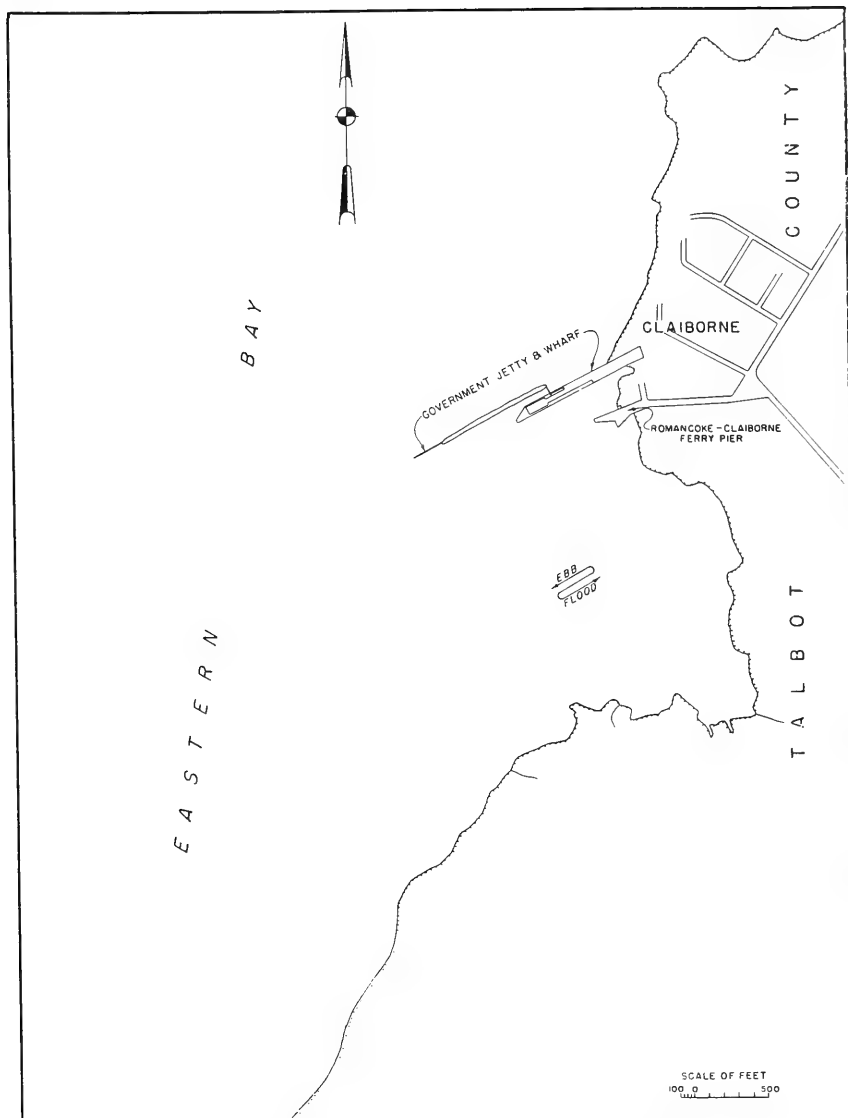
Figure 53. Claiborne Harbor, Maryland

<u>Date(s)</u>	<u>Construction and Rehabilitation History</u>
1888	A 750-ft-long slag jetty was constructed by a railway company at Claiborne Harbor.
1912	The jetty was extended 250 ft seaward as part of the federal project and was constructed of timber piles (Figure 53).
1928	The timber pile extension was in poor condition and was missing a seaward section.
1970's	The jetty was repaired, and revetment was placed around the jetty and wharf area of the harbor by non-Federal interests.
1978	A report recommended removal of deteriorated timber piles.
1981	A survey indicated the jetty was in excellent condition.
1986	Plans are complete for jetty rehabilitation. No details are available.

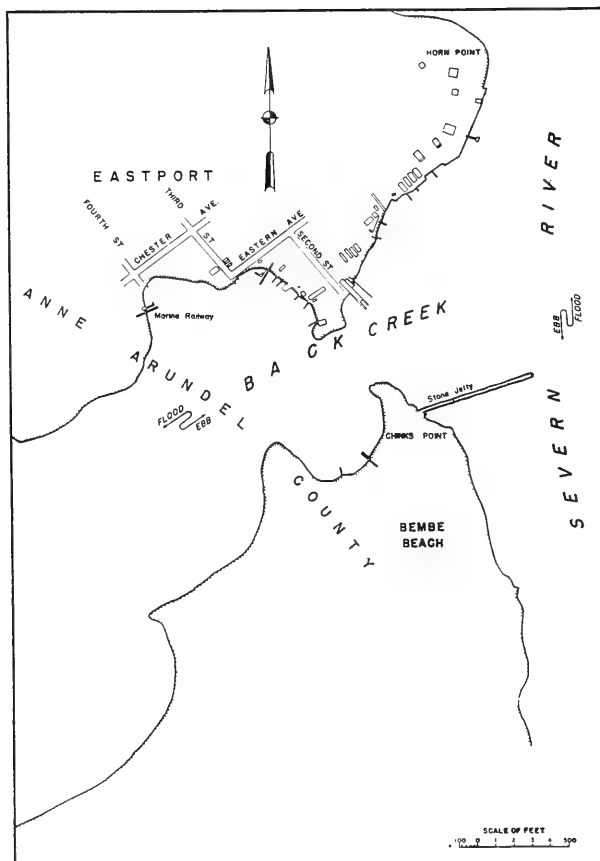
Figure 54. Back Creek, Maryland

<u>Date(s)</u>	<u>Construction and Rehabilitation History</u>
1938-1939	A 650-ft-long jetty was constructed to a crest elevation of +4.0 ft mhw (Figure 54). Crown width was 4.0 ft with a single capstone, and side slopes were 1V:2H.
1981	A survey indicated the jetty was in very good condition.
1986	No further repair or maintenance information has been found.

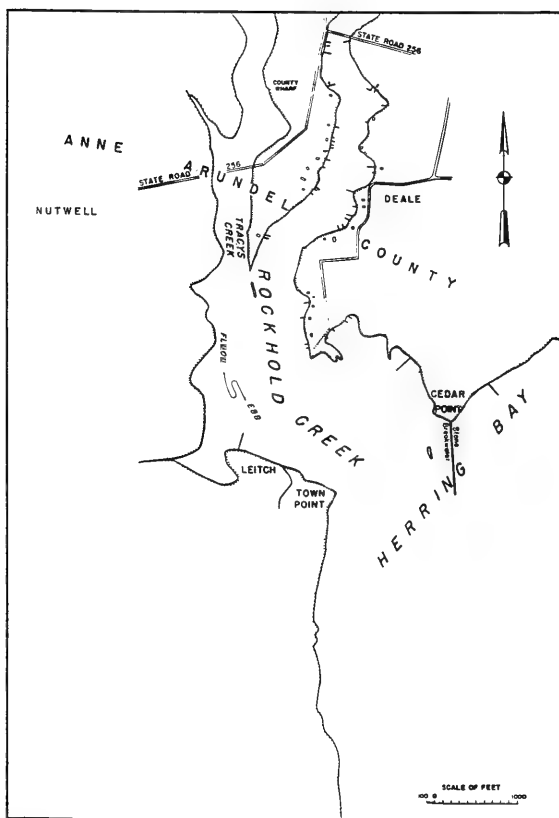
Figure 55. Herring Bay and Rockhold Creek, Maryland

<u>Date(s)</u>	<u>Construction and Rehabilitation History</u>
1939-1940	A 900-ft-long stone breakwater was constructed to a crown elevation of +4.0 ft mhw (Figure 55). Crown width was 4.0 ft, and side slopes were 1V:1.5H.
1981	A survey indicated that the structure was in good condition with very little subsidence.
1986	No further repair or maintenance information has been found.

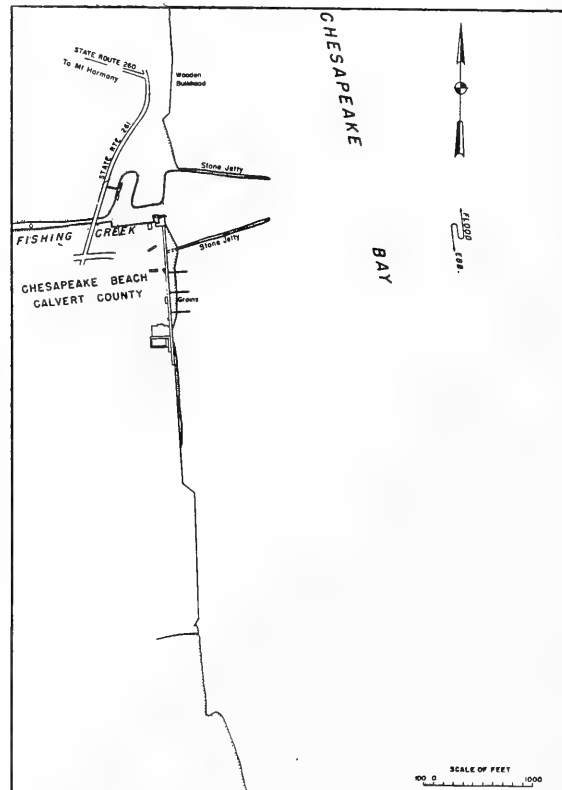
Figure 56. Fishing Creek, Maryland

<u>Date(s)</u>	<u>Construction and Rehabilitation History</u>
1941- 1942	Two converging stone jetties were constructed to lengths of 1,050 and 1,100 ft north and south, respectively (Figure 56). Crown elevation was +4.0 ft mlw, crown width was 4.0 ft, and side slopes were 1V:1.5H.
1981	A survey revealed that both jetties were in good condition with minor settlement and some displaced stone.
1985	Plans call for sand tightening of the jetties with 2,100 to 3,500 lb of cover stone, 20 to 100 lb of core stone, and 1.0 to 20 lb of bedding stone.

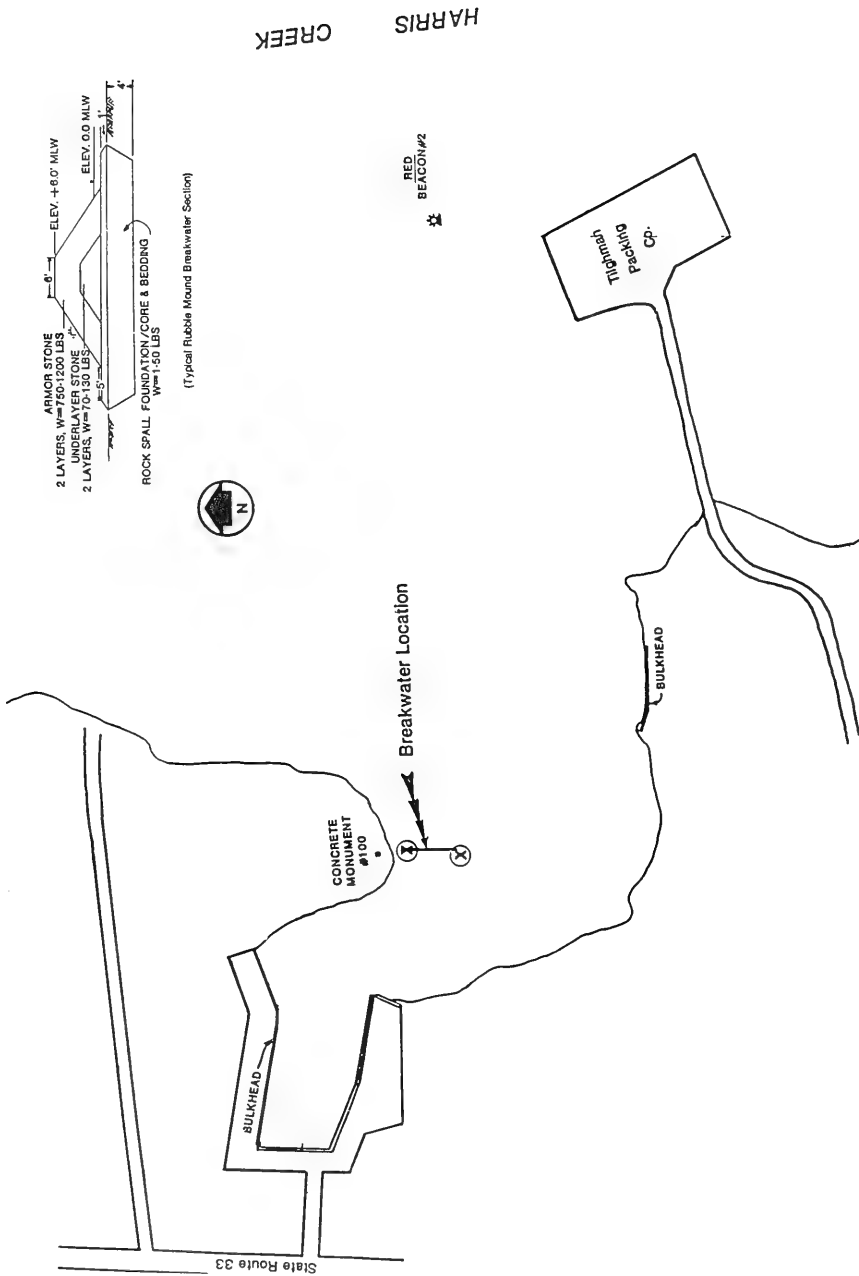
Figure 57. Tilghman Island, Maryland

<u>Date(s)</u>	<u>Construction and Rehabilitation History</u>
1981	A 200-ft-long breakwater was constructed at an estimated cost of \$140,000 with 1,750 tons of stone to reduce wave action in the inner harbor area (Figure 57). Crown elevation was +6.0 ft mlw and allowed for expected settling to +5.0 ft mlw. Crown width was 6.0 ft, and side slopes were 1V:1.5H. The structure consisted of two layers of armor stone, 750 to 1,200 lb and 70 to 130 lb, and a 1- to 50-lb core and bedding layer. Design wave height and period were 2.3 ft and 4.0 sec.
1986	No further repair or maintenance information has been found.

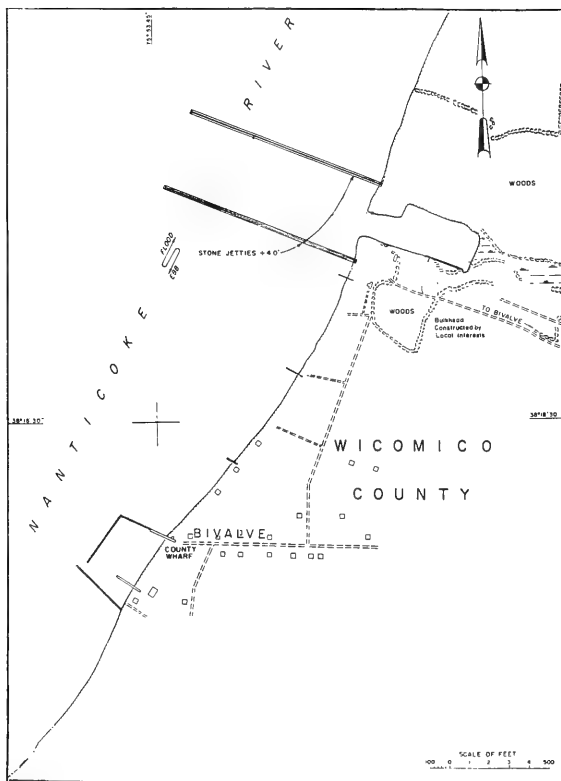
Figure 58. Nanticoke River at Bivalve, Maryland

<u>Date(s)</u>	<u>Construction and Rehabilitation History</u>
1960	Two jetties were constructed at lengths of 1,050 ft each and spaced 400 ft apart (Figure 58). Crown elevation was +4.0 ft mhw, crown width was 4.0 ft with a single capstone, and side slopes were 1V:2H. Minimum coverstone weight was 1.5 tons, and corestone ranged from 15 to 500 lb with a 1.0-ft-thick bedding layer. Design wave height was 7.0 ft.
1985	Both jetties are in excellent condition; however, present shoaling in the channel may be due to sand passing through the jetties.

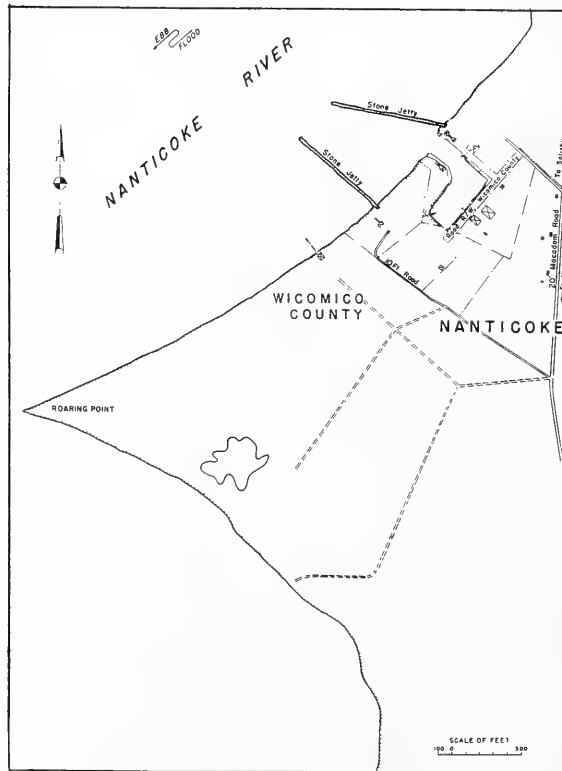
Figure 59. Nanticoke River at Nanticoke, Maryland

<u>Date(s)</u>	<u>Construction and Rehabilitation History</u>
1938	Two converging stone jetties were constructed at lengths of 850 ft and 750 ft north and south, respectively (Figure 59). Crown elevation was +5.0 ft mhw, crown width was 4.0 ft, with a single capstone, and side slopes were 1V:1.5H. A post-construction survey showed little deviation from the design elevation.
1944	A survey of the jetties indicated little change in crown elevation.
1981	A survey indicated both jetties were in excellent condition.
1986	No further repair or maintenance information has been found.
